SITE: Florida Phosphate
BREAK: 17.8
OTHER: v. 18

January 11, 1978

Lloyd Godwin, Director
Florida Sheriff's Girls Villa
Post Office Box 1380
Bartow, Florida 33830

The following data was obtained from designated various sampling points in homes located in Florida Sheriff's Girls Villa.

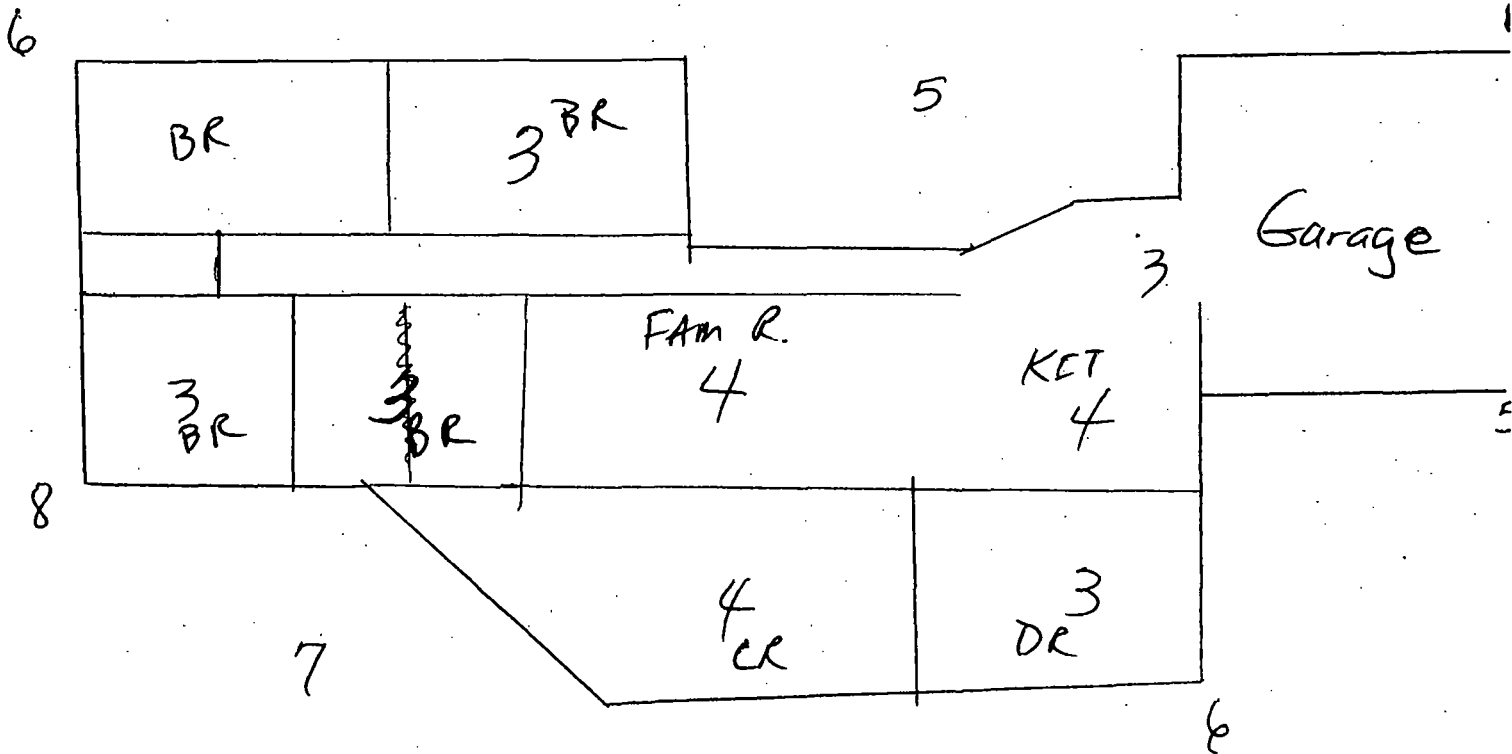
FIELD REPORT ON Staff Residence (Godwin) Girls Villa
 TOWN VISITED Bartow DATE 5/10/77
 OWNER OF PROPERTY Girls Villa PERSON SEEN Whitney & Godwin
 BY WHOM W. Hall & Moore TIME SPENT 30 min
 REASON FOR VISIT Gamma survey & pump installation

Front

EPA Ludlum 3644

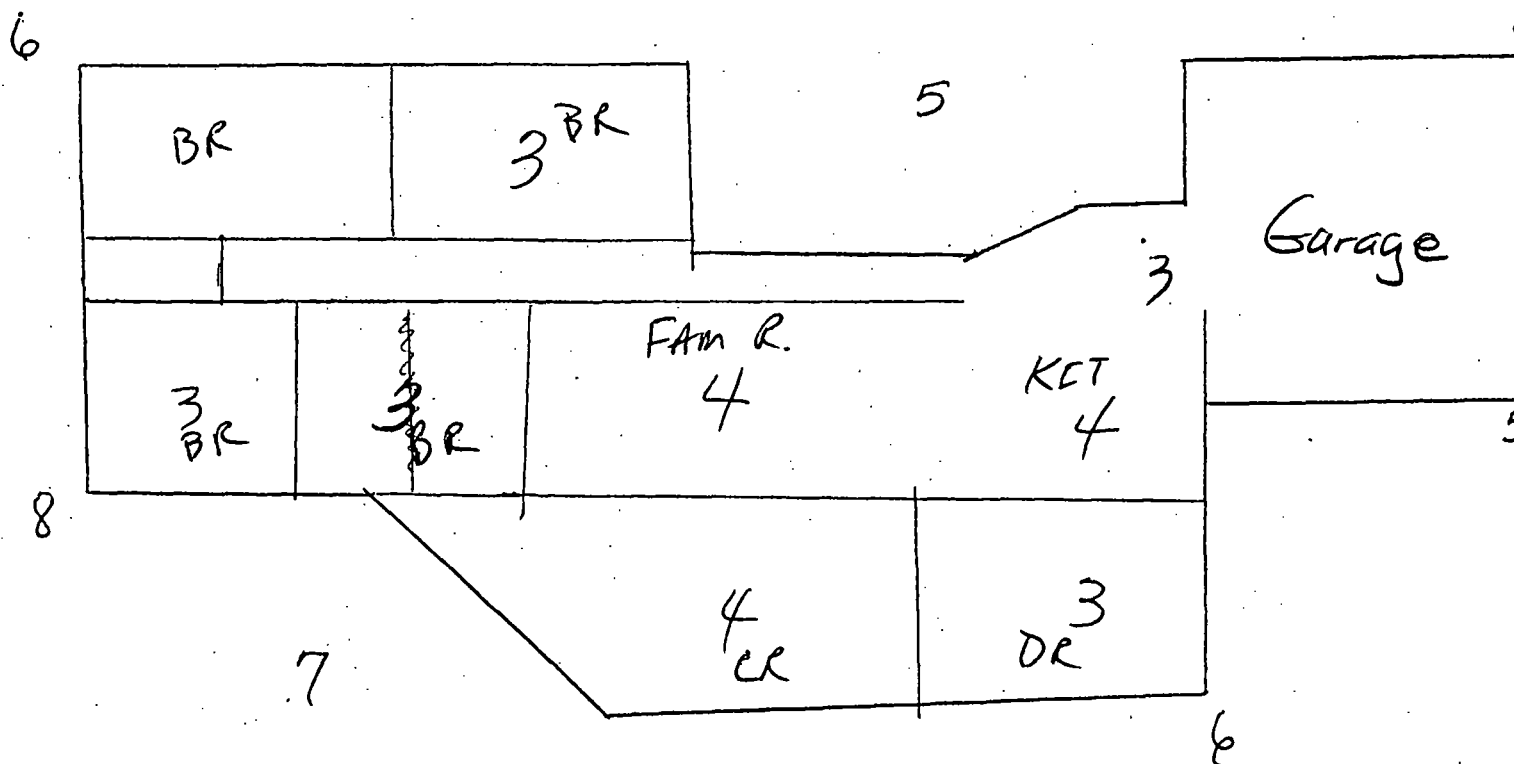
REPORT: Loc # 71398

FIELD REPORT ON Staff Residence (Godwin) Girls Villa
 TOWN VISITED Bartow DATE 5/10/77
 OWNER OF PROPERTY Girls Villa PERSON SEEN Whitney & Galwin
 BY WHOM W. Hall & Moore TIME SPENT 30 min
 REASON FOR VISIT Gamma survey & pump installation

Front

EPA Ludlum 364
